Report on Inspections of Household Freezers

Prepared for
Gene Hallworth
714-A Trotwood Avenue
P. O. Box 938
Columbia, TN 38402-0938

Prepared by
J. A. M. Boulet
8507 Dresden Drive
Knoxville, TN 37923

Observations

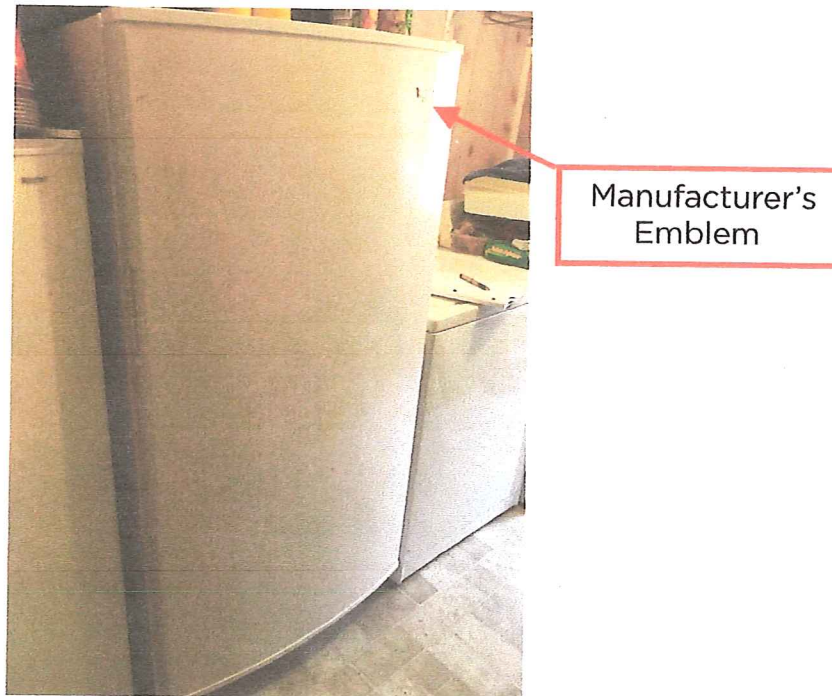
On December 19, 2016, at the request of Mr. Gene Hallworth, attorney, the author inspected and photographed a freezer at the home of Ms. Gracie Hunt Craun at 219 Meadowlark Drive, Pulaski, Tennessee. Ms. Craun indicated that the inspected freezer was a replacement for one that had been defective. Figure 1 is a photograph of the freezer.

Fig. 1 Replacement Freeze at Craun Residence

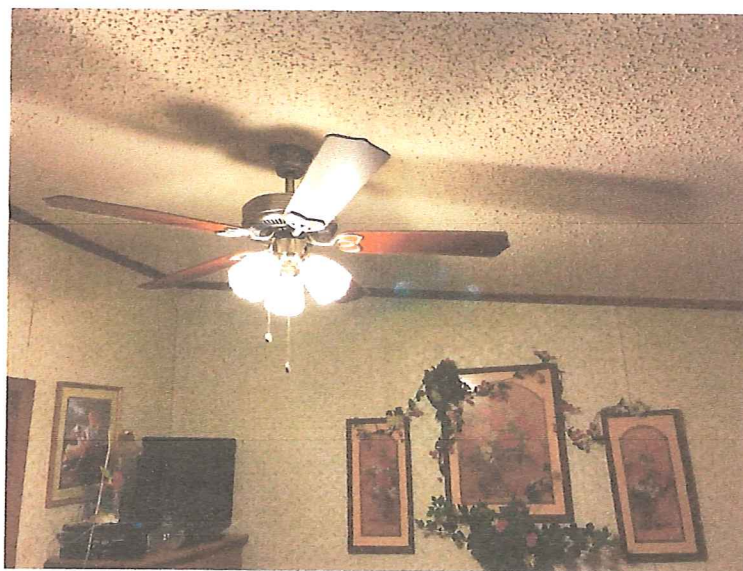
Figure 4 shows a ceiling fan that Ms. Craun said was installed on the same day as the freezer that leaked and has worked normally ever since.

Fig. 4 Ceiling Fan at Craun Residence

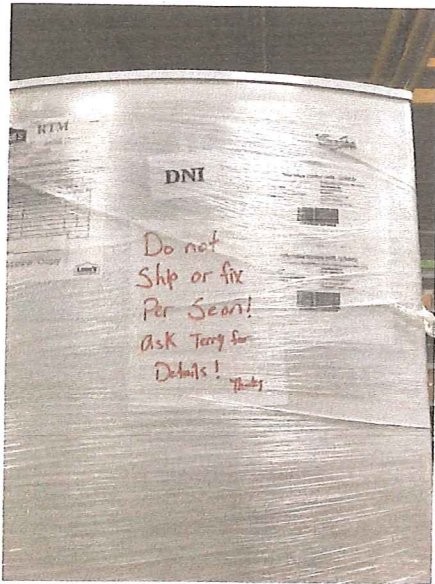
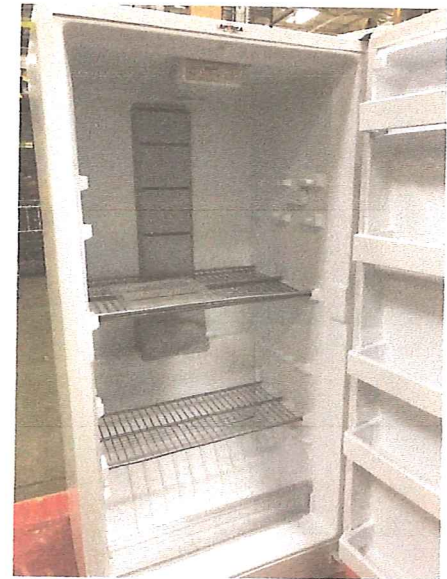
Note the stain on the fibrous panel, which covers the compartment housing the compressor. Figures 7 and 8 show the front of the freezer prior to inspection and the interior of the freezer, respectively.

Fig. 7, 8 Front and Interior of Freezer at Lowe's

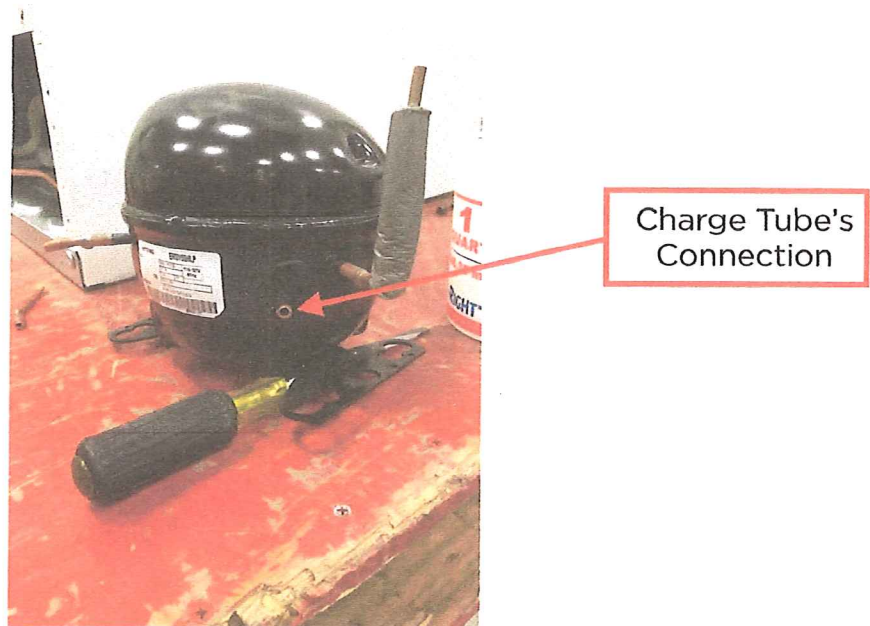
Figure 16 shows the compressor after the charge tube was cut away and after the compressor was removed from the freezer.

Fig. 16 Compressor after Being Removed from Freezer

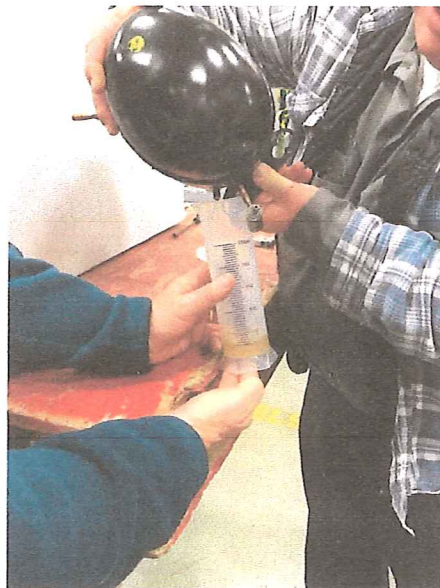
Figure 17 shows oil being poured out of the compressor through the hole left by cutting away the charge tube.

Fig. 17 Pouring Oil from Compressor

4. Absence of refrigerant in the compressor did not cause the motor to run continuously until it was damaged.
5. Less than 75 milliliters of oil (45 ml at Lowe's, less than 30 ml at the machine shop) was recovered from the compressor. Hence, the total volume of oil remaining in the compressor was less than half of the total oil in the system as indicated by the compressor's information sticker in Figures 13 and 20 (150 cc = 150 milliliters).

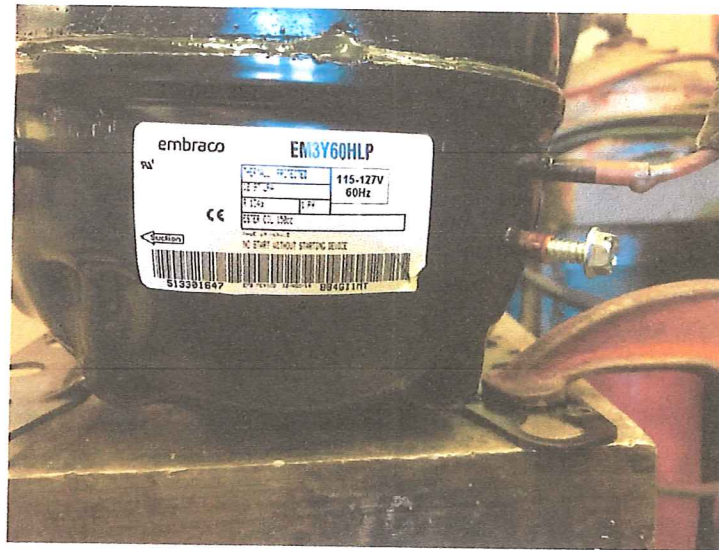
Figure 20 shows the compressor's information sticker.

Fig. 20 Compressor's Information Sticker
